## *Critical Aquifer Recharge Areas Report*

### **PENNY LANE II & III**

Redmond, Washington

Project No. 180106E001

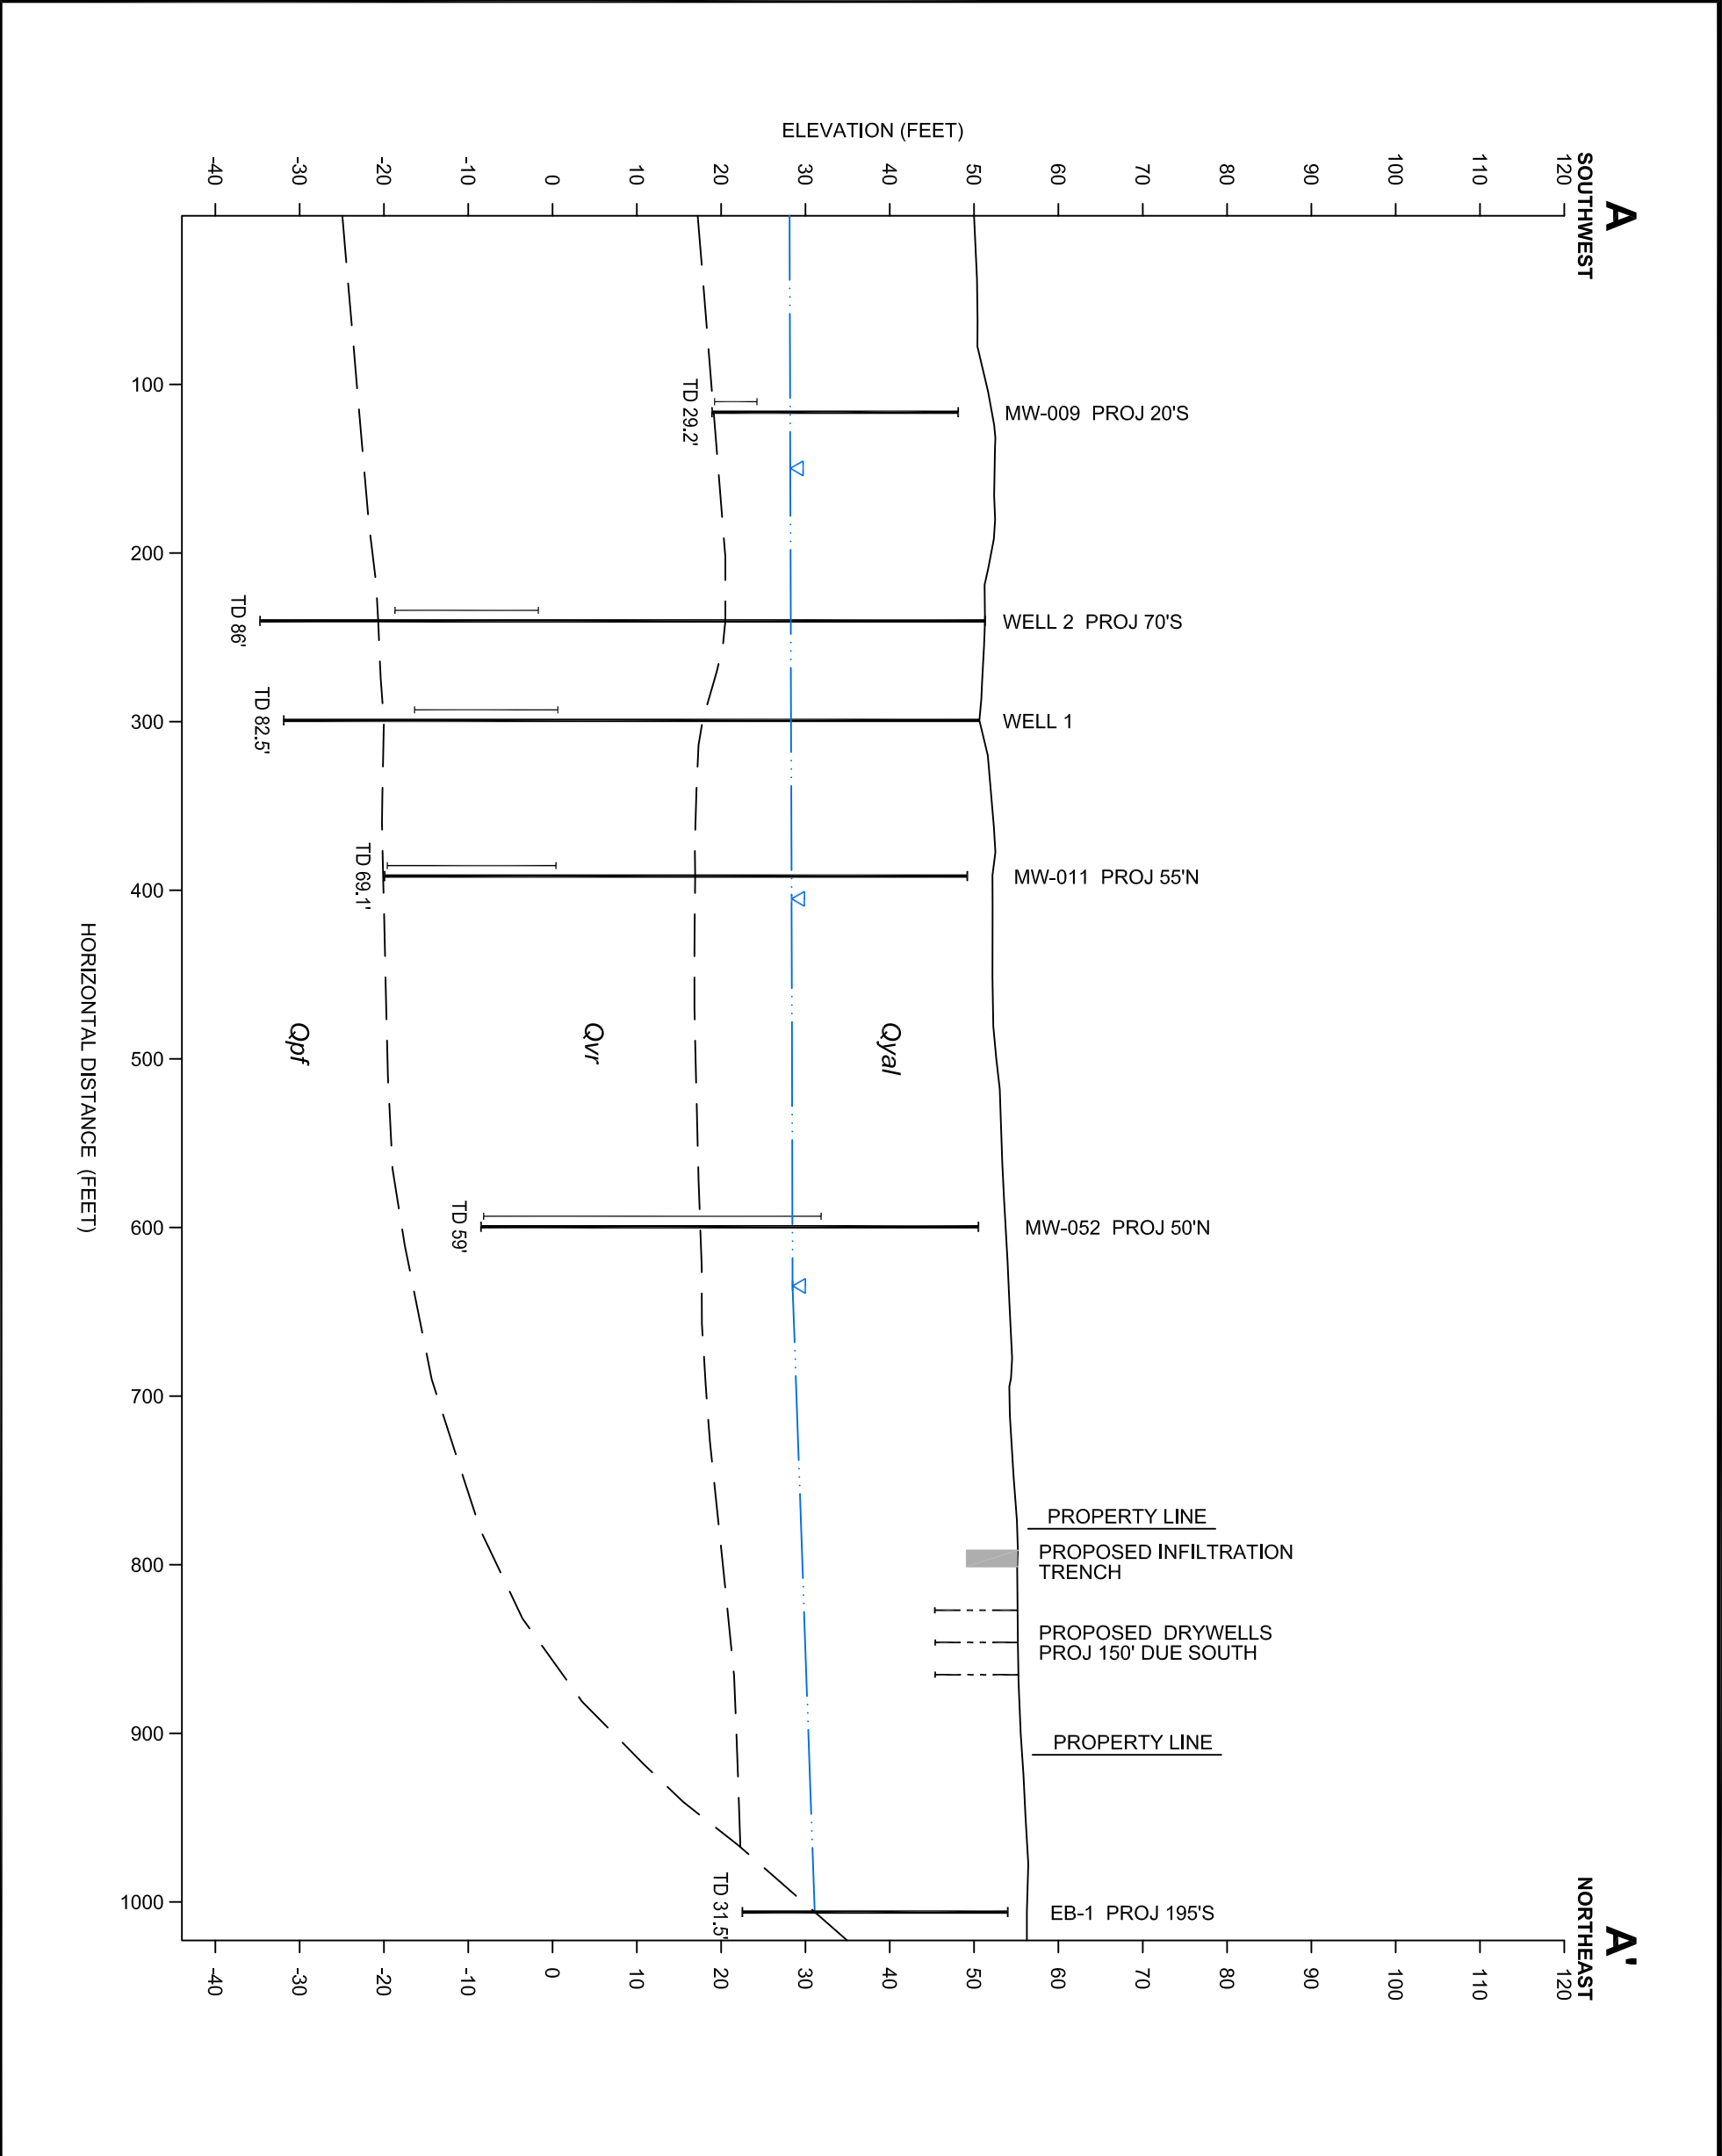
occur between May and October (dry season). Dry season water levels are expected to be around 26 feet elevation (27 feet bgs) at the project site. Figure 6 presents a generalized cross-section showing anticipated maximum excavation depths of proposed infiltration drywell/trench systems on the site in relationship to groundwater elevation, and City monitoring and water supply wells in the vicinity of the site. The groundwater elevations depicted on Figure 6 are based on Golder 2018a.

- QyaI* / YOUNGER ALLUVIUM
- Qvr* / VASHON RECESSSIONAL OUTWASH
- Qpf* / PRE - FRASER SEDIMENTS
- Well / BORING
- SCREENED INTERVAL
- TD / TOTAL DEPTH OF BORING
- Geologic CONTACT
- GROUNDWATER ELEVATIONS BASED ON WINTER 2018 MONITORING REPORT - GOLDER 2018A

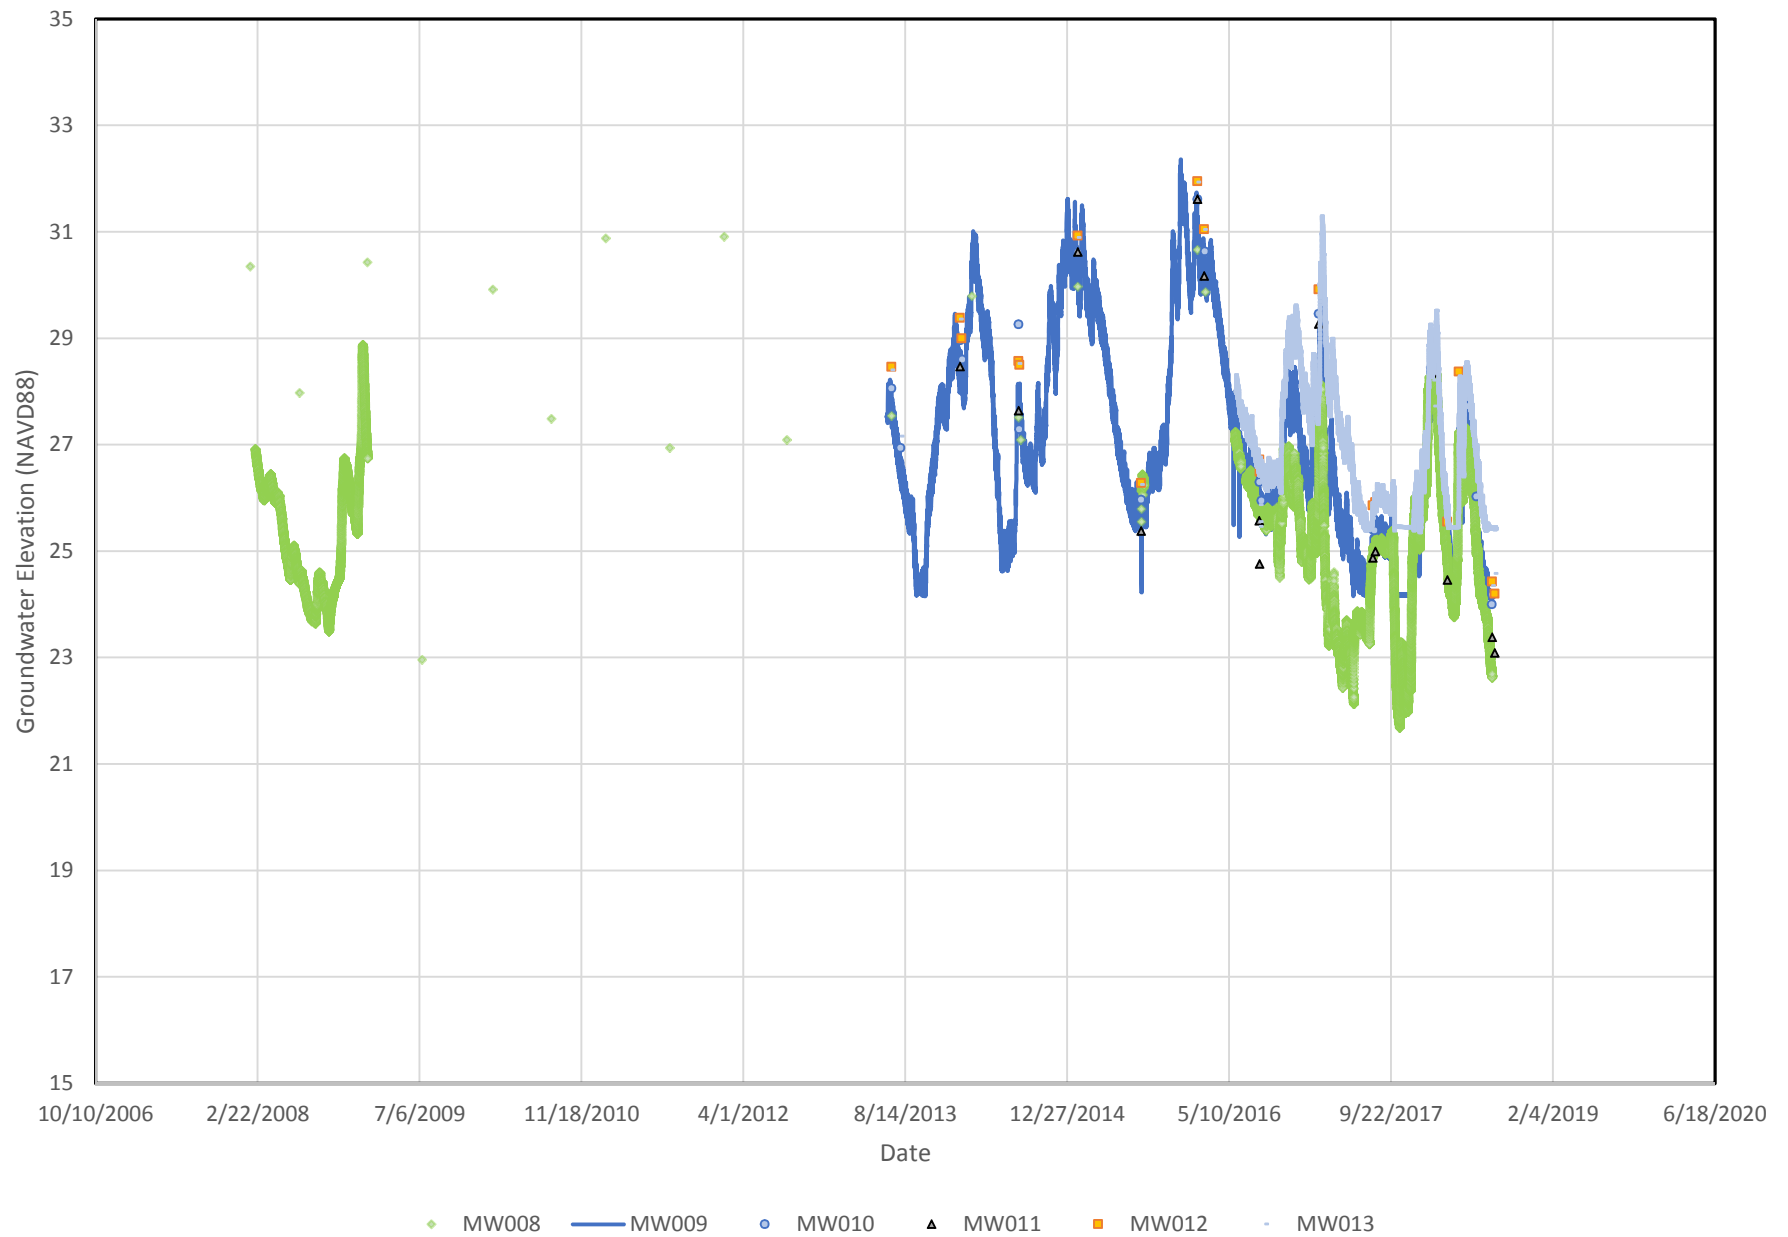
Figure C1  
 Project No. 180106E001  
 Date: 04/2019

Groundwater Hydrograph  
 MW008, MW009, MW010, MW011, MW012, MW013  
 City of Redmond Monitoring Wells

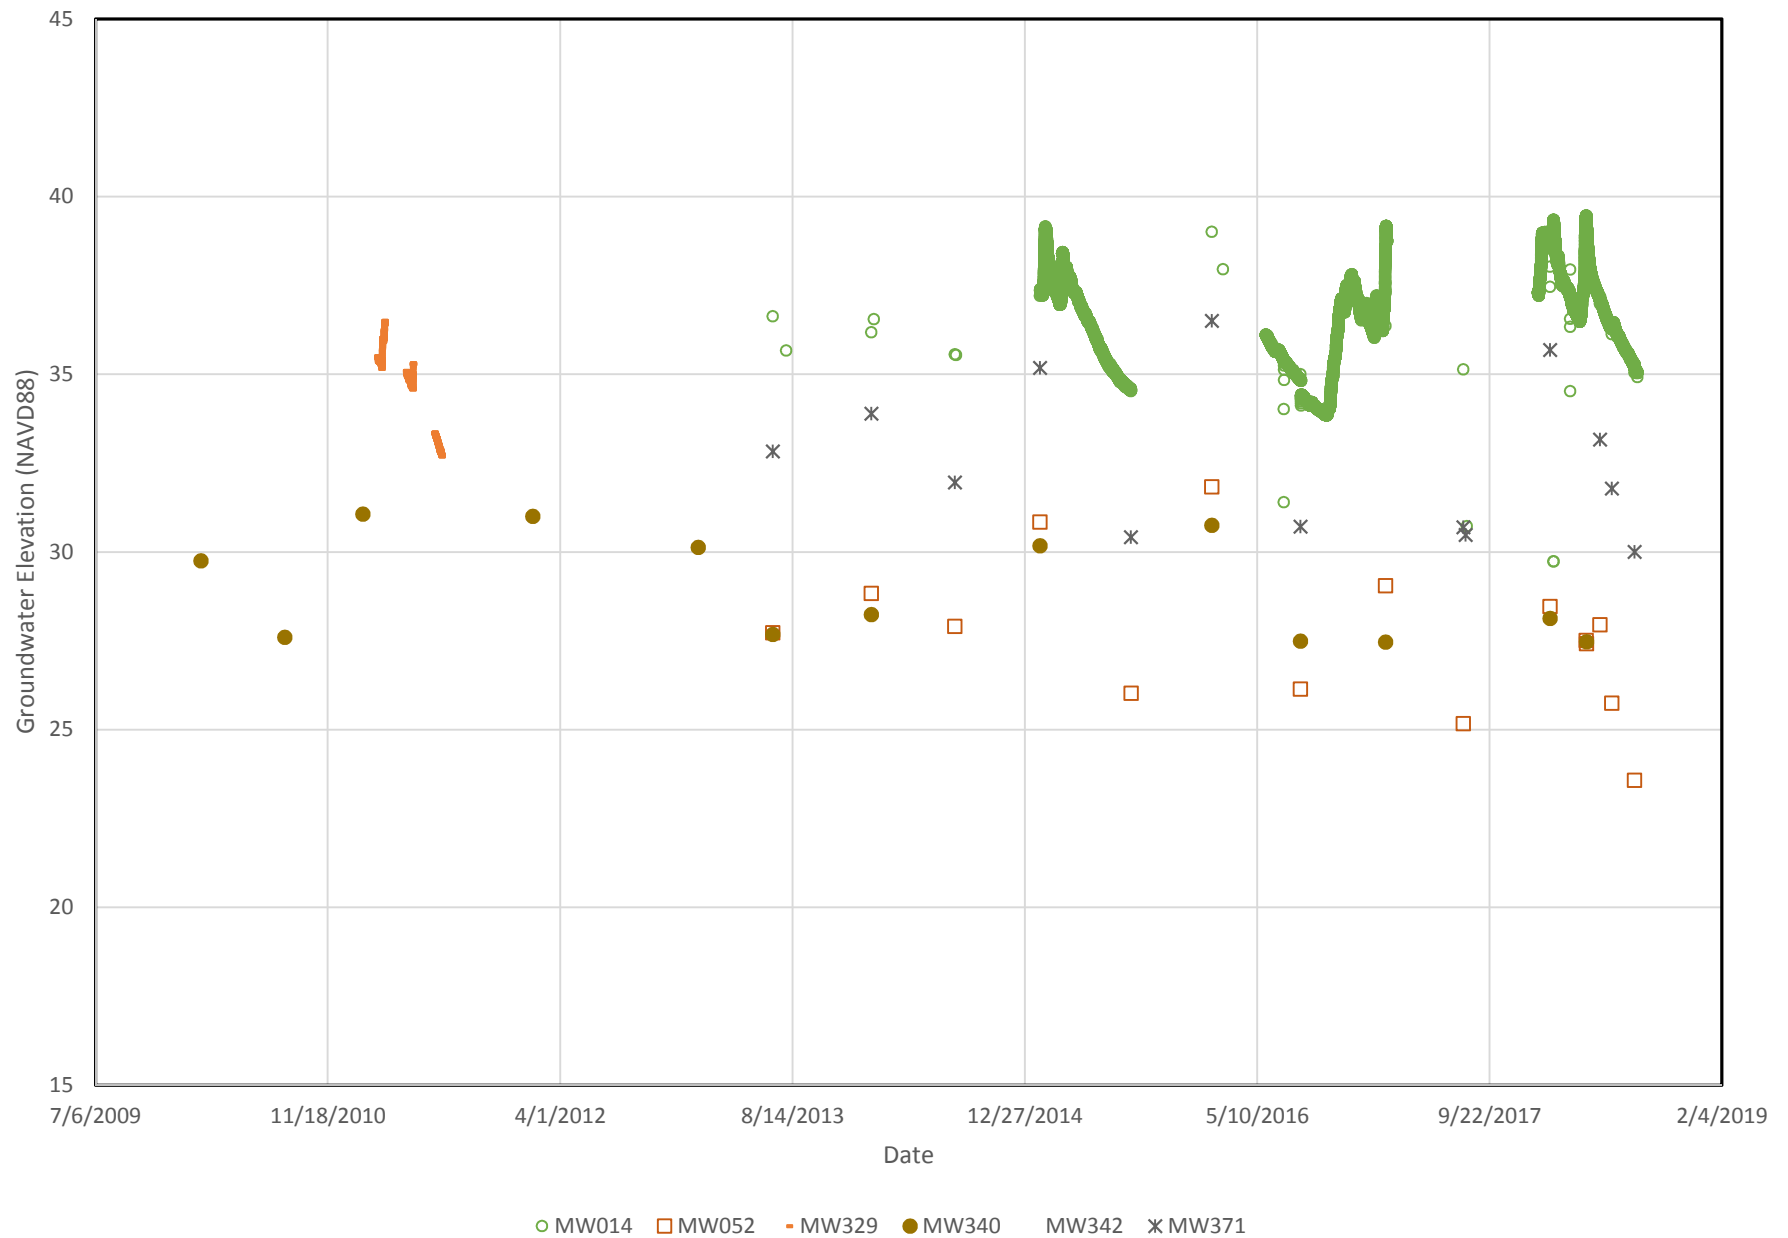
Figure C2  
 Project No. 180106E001  
 Date: 04/2019

Groundwater Hydrograph  
 MW014, MW052, MW329, MW342, MW371  
 City of Redmond Monitoring Wells

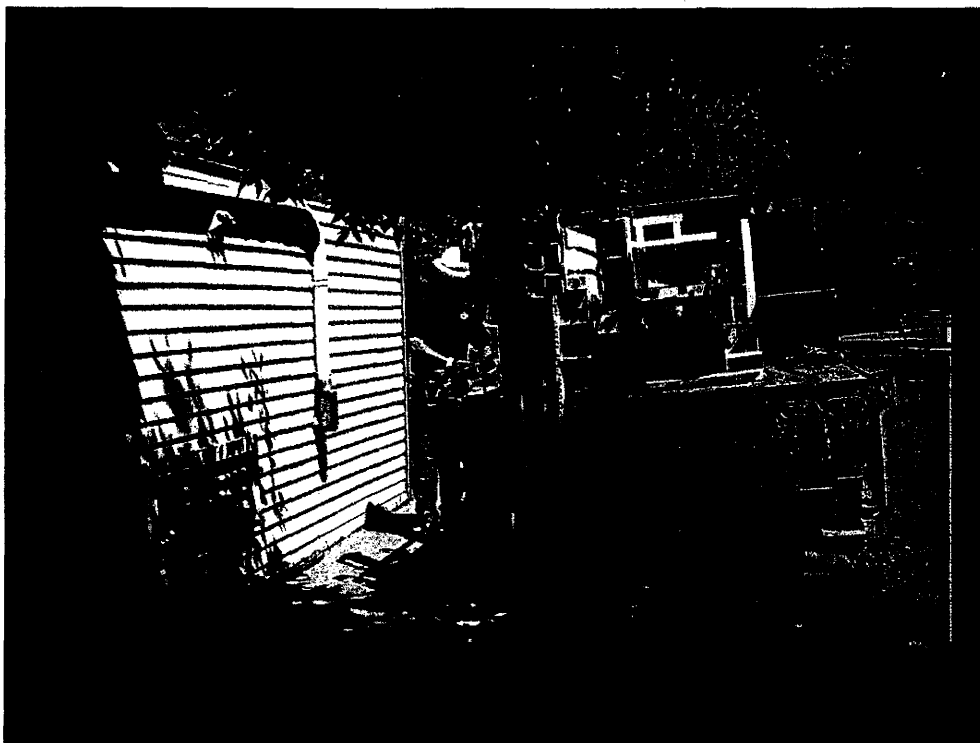
Drilling of boring SB-5; July 2, 2007.
